Inspection Report

J & K Inspections, LLC

908 Black Hills Drive
Spearfish, SD 57783

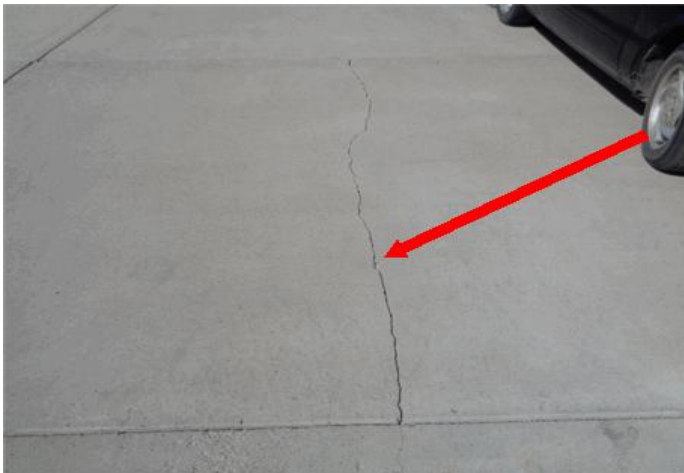
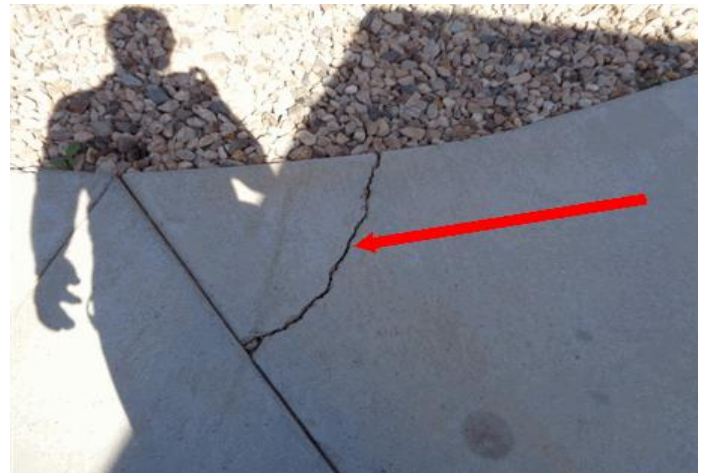
2) Driveway Conditions**R**

Major cracks were found in the driveway. Cracks need to be sealed to prevent water intrusion and further deterioration.

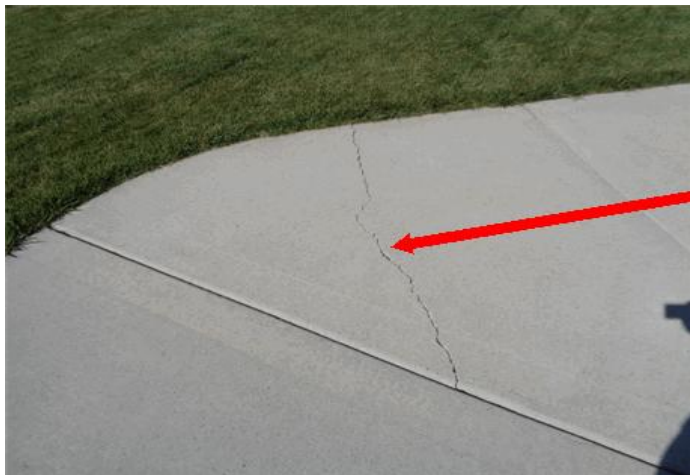
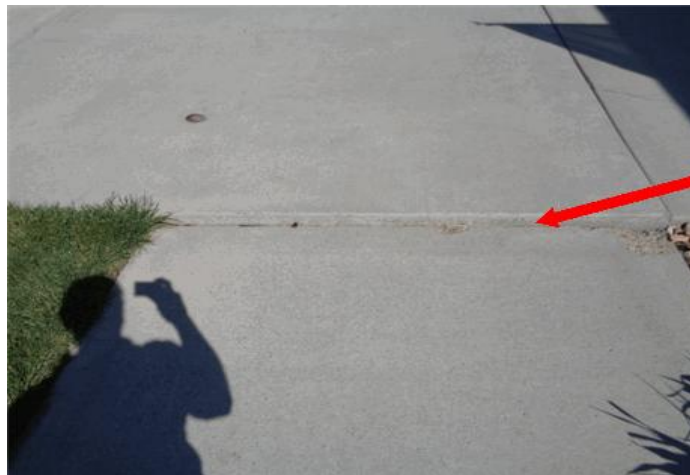
3) Sidewalk Conditions**S**

The surface of the front walk where it meets the driveway was raised or settled. This may cause tripping hazards. This should be repaired for safety. Any rise less than four inches is considered a trip step. The cracks in the sidewalk should be sealed or caulked to prevent water intrusion and further deterioration.

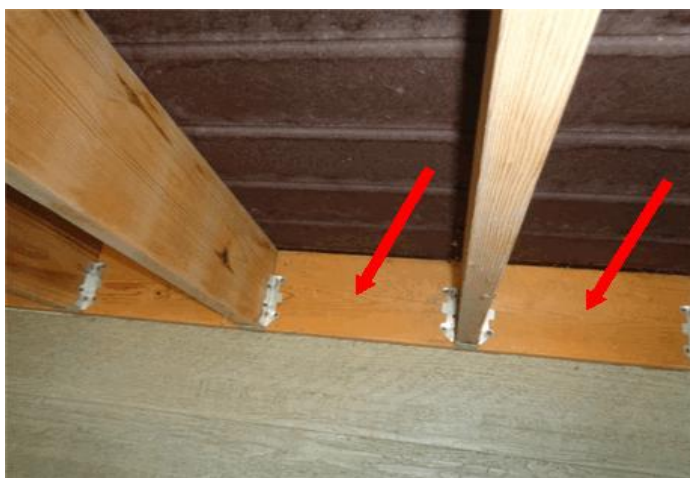
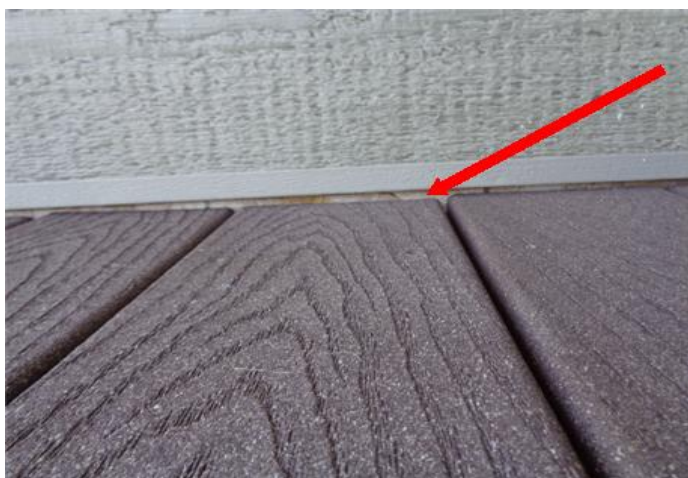
6) Front Entrance Conditions

The front deck does not appear to have flashing behind it which can cause water intrusion and rotting behind the ledger board and siding. The deck is not properly secured to the home with lag bolts. Recommend repairs as needed.

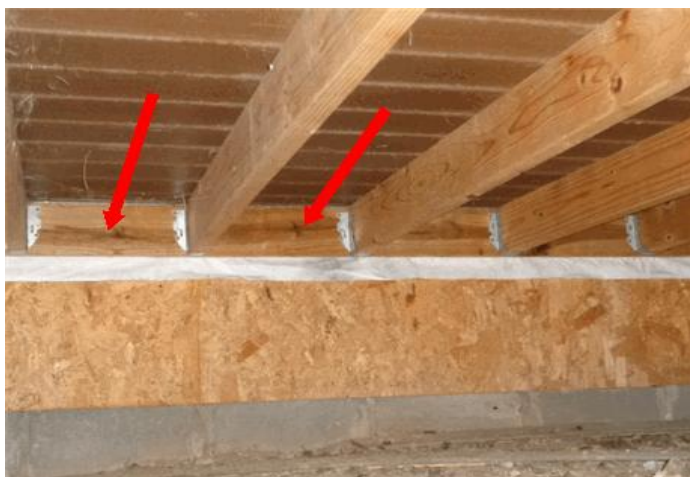
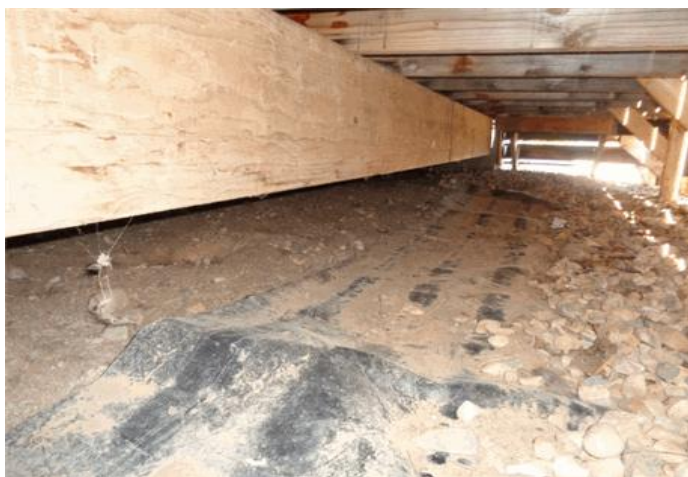
7) Back Entrance Conditions

The back deck is not properly secured to the home with lag bolts. The deck has a lot of deflection. There should be a mid-span support under the girder. Recommend repairs as needed.

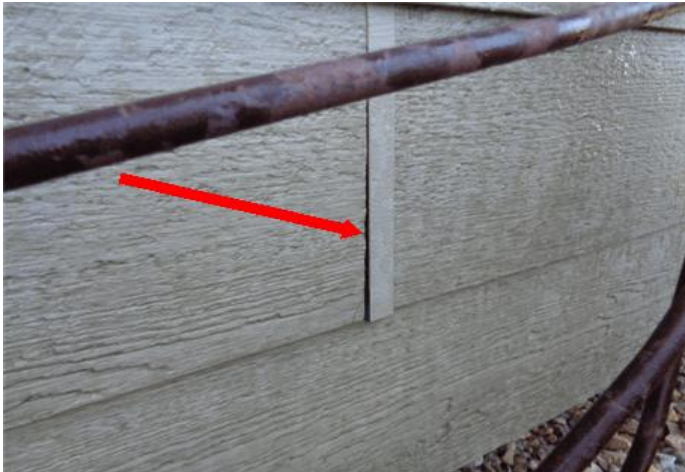
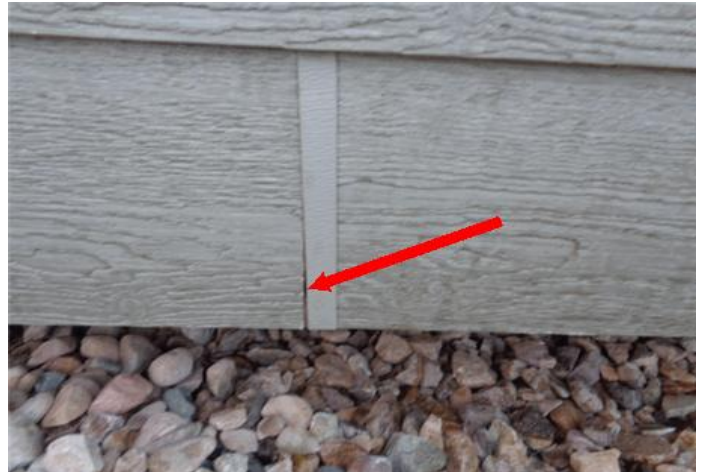
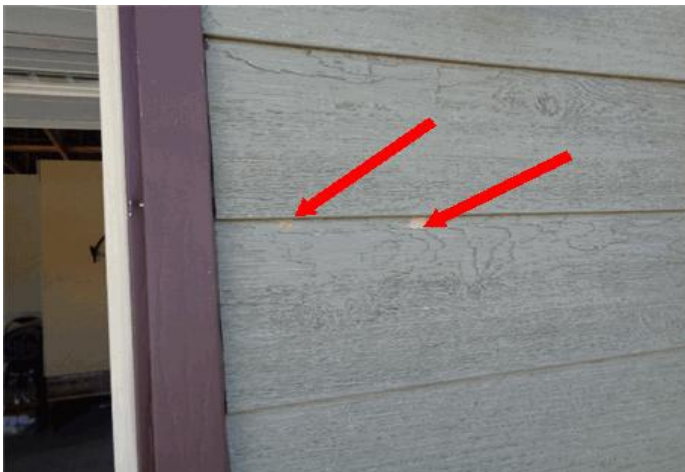
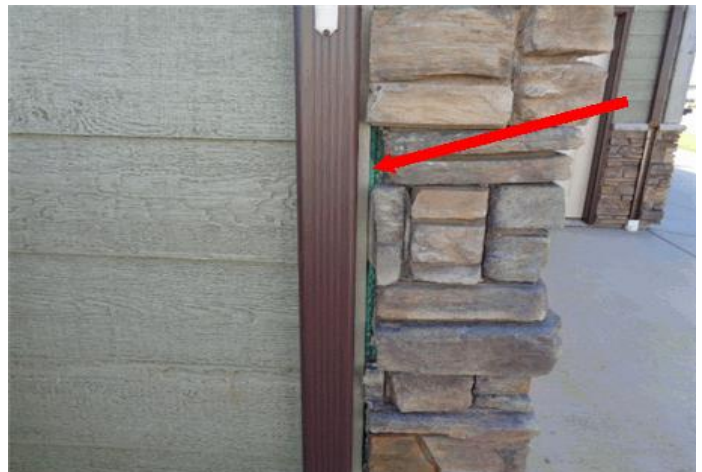
8) Exterior Wall Conditions**R**

There are several siding joint splices that don't fully cover the siding joint which can allow moisture and insect intrusion. There are some areas of chipped paint exposing bare wood which can lead to moisture damage. There are several locations where there is mortar missing beside the stone veneer which can lead to moisture damage to the exterior sheathing. Recommend repairs as needed.

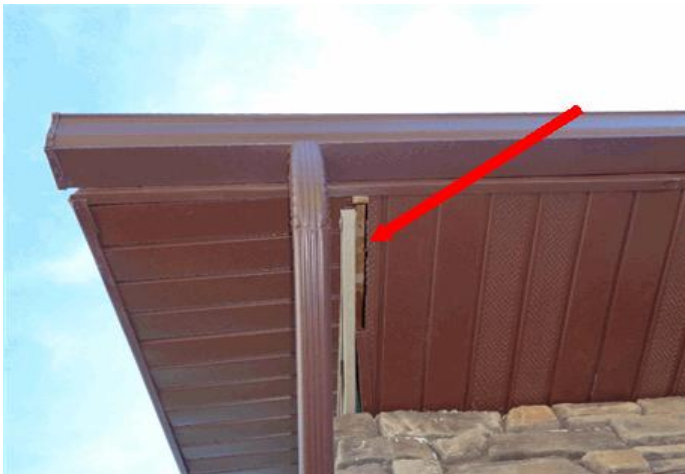
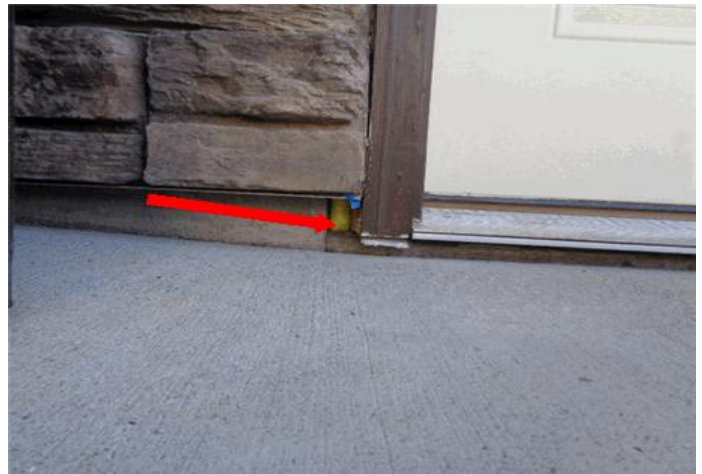
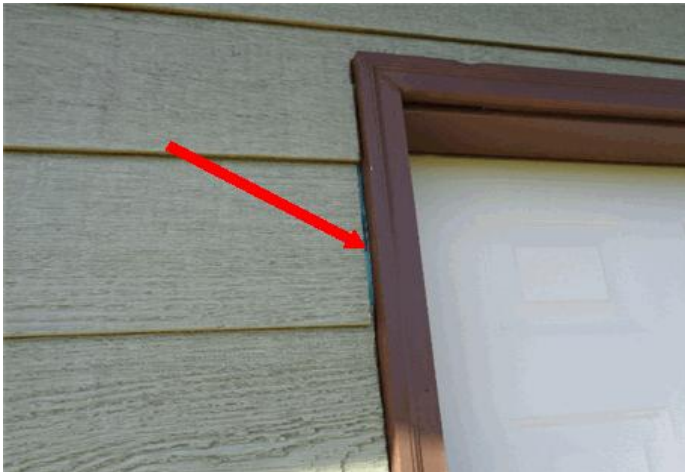
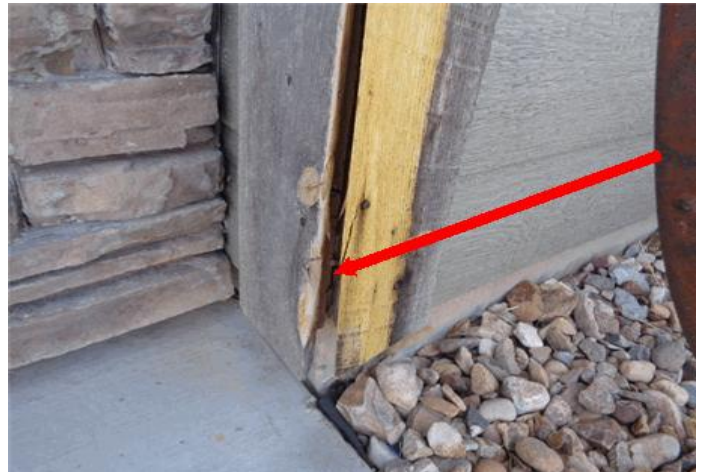
AS = Appears Serviceable**R = Repair****S = Safety****NI = Not Inspected****9) Fascia - Soffit - Trim Conditions****R**

On soffit in front, there is J-Channel missing exposing an open joint which can lead to insect, bat, rodent intrusion. On side man door going into the front garage is a gap that needs to be sealed. Also there is a big gap around the man door going into garage that needs to be caulked. On all exterior outside corners the corner boards are separating and curling away from the home. These need to be resecured and pulled together and joints caulked to prevent insect and moisture intrusion.

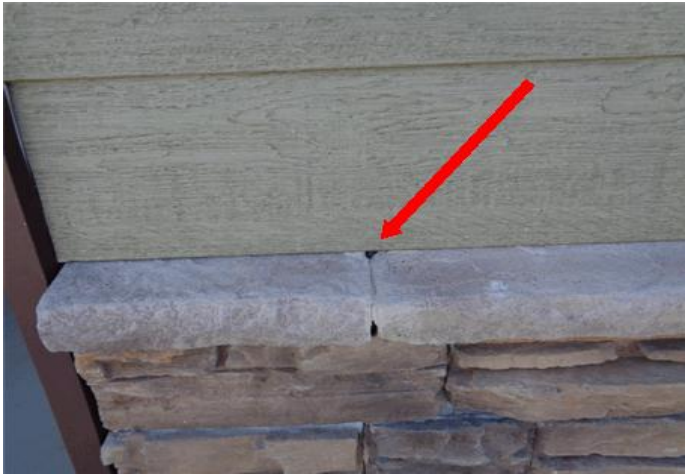
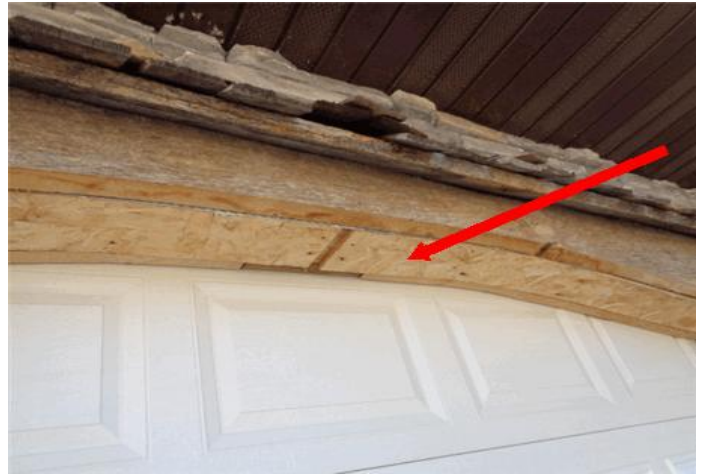
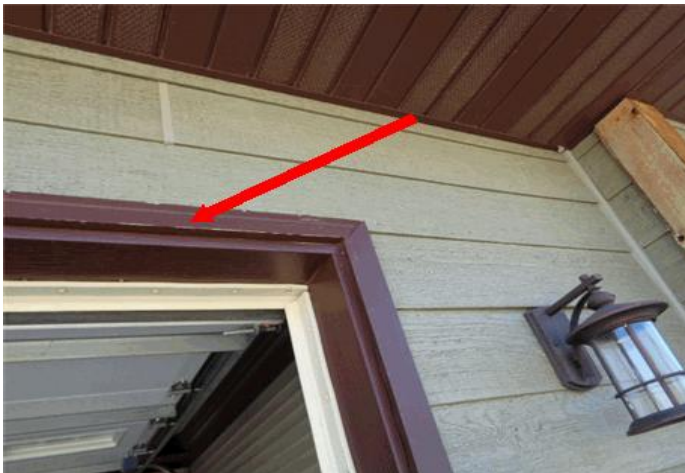
**10) Exterior continued****R**

On front right side of overhead garage door, the stone cap needs to be sealed to prevent water intrusion (and in the winter the water freezing and resulting in popping loose of stones). Archway over left side overhead garage door has exposed OSB sheathing. This needs to be covered. On right overhead garage door the head piece of brick mold is missing aluminum wrap.

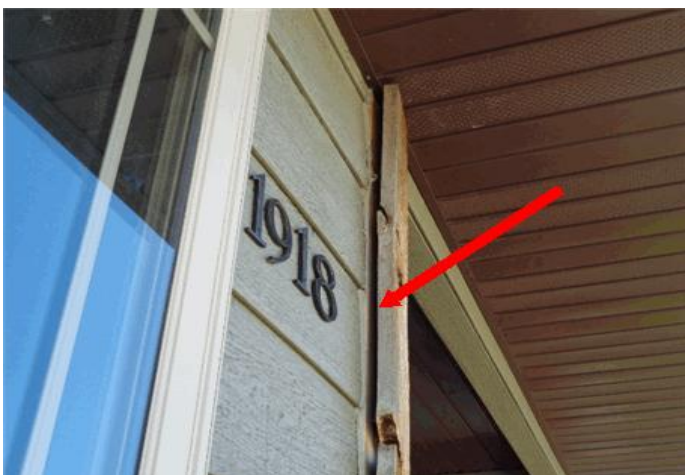
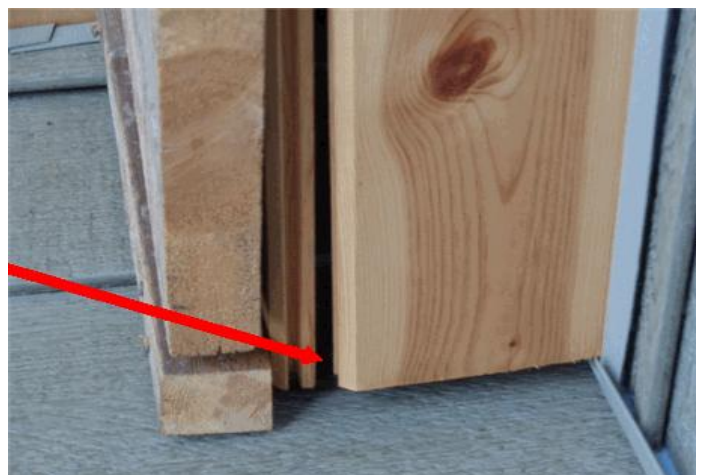
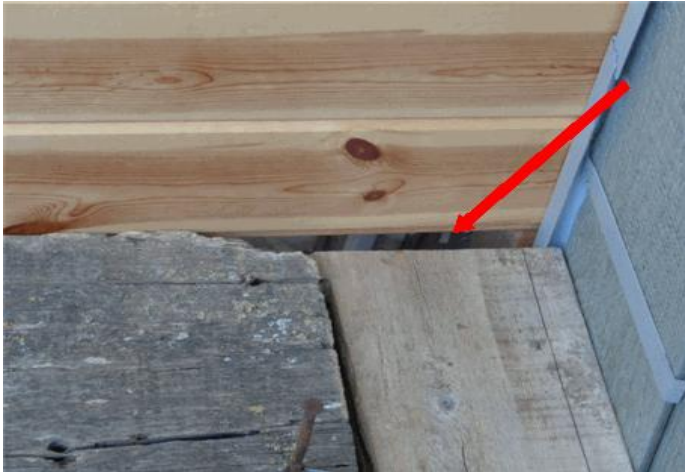
11) Exterior continued -

On left side on back deck under decorative barn board is a large gap in the soffit that needs to be sealed. On back deck, on right hand upper corner there is a large gap that needs to be sealed to prevent insect, bat, rodent, etc., intrusion.

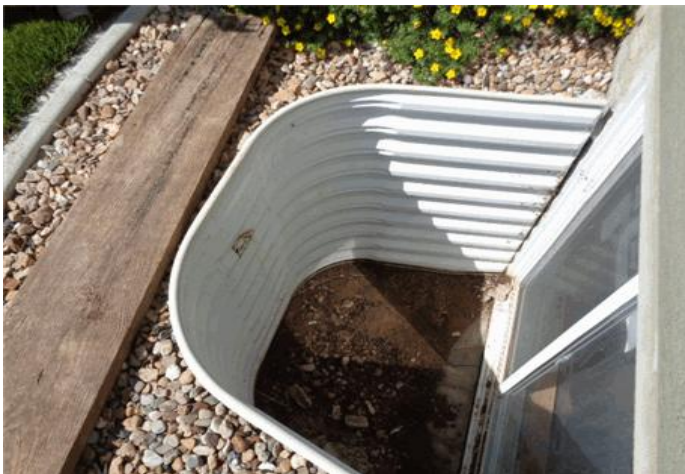
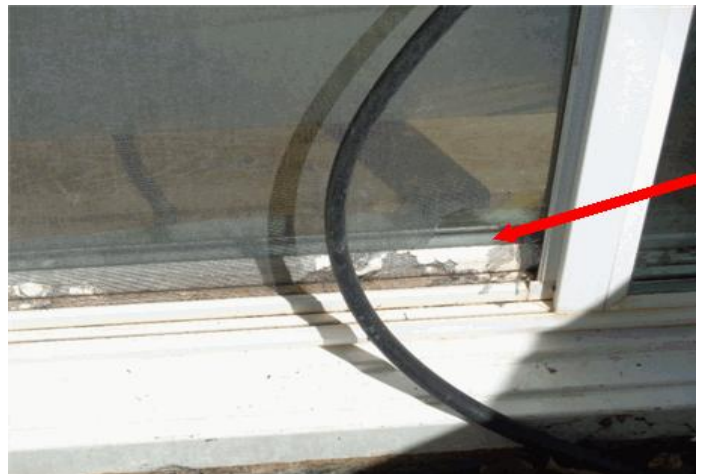
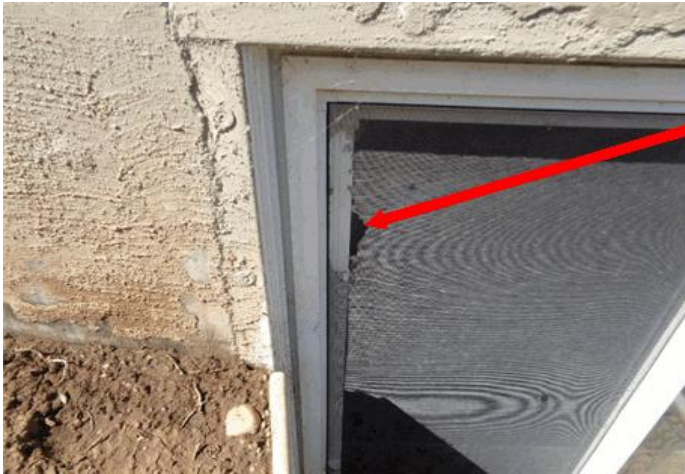
**Exterior Windows - Doors****Window Type** Sliding**Window Material** Vinyl**12) Window Conditions****R**

The two egress basement windows on east side of home are missing escape ladders. The screens are torn on the basement windows on east and north side of home.

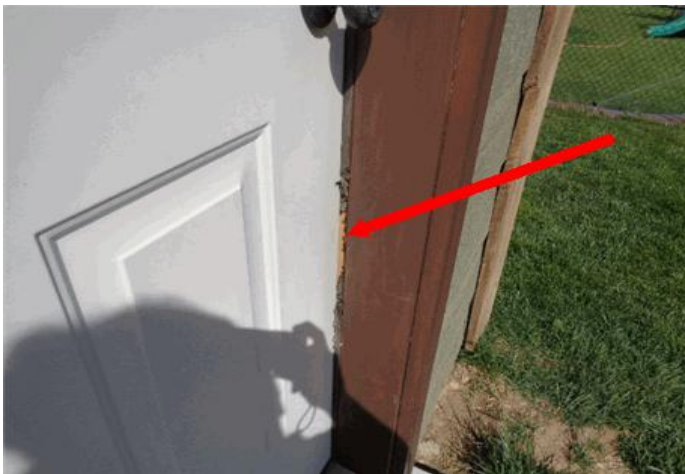
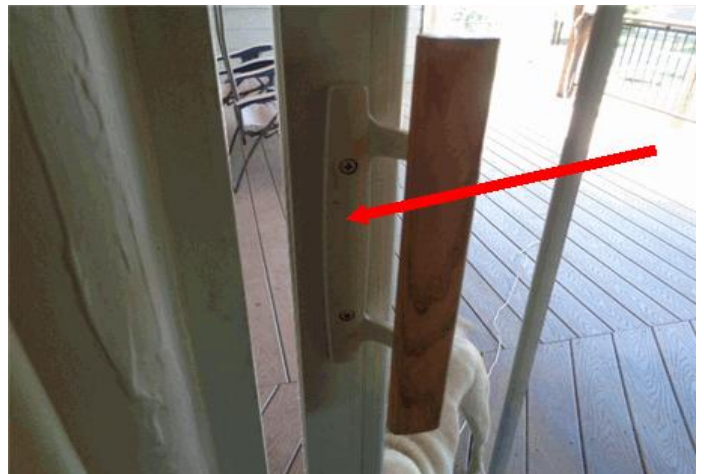
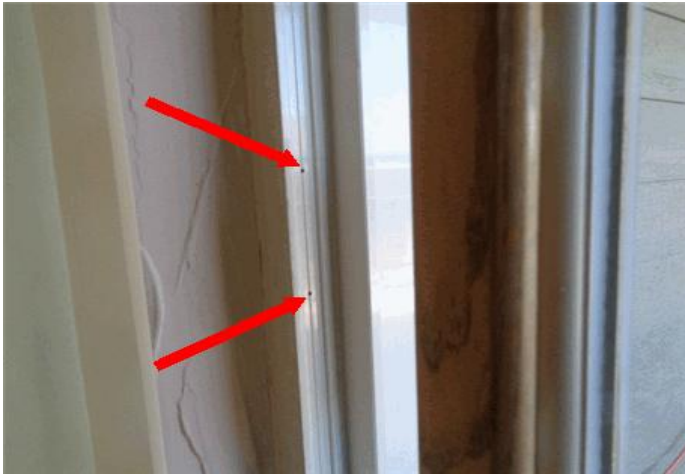
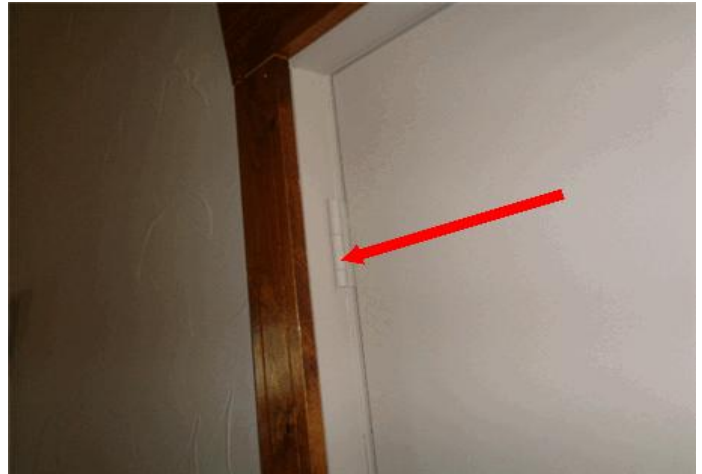
**13) Exterior Door Conditions****S**

Weather stripping is damaged on the back man door to garage. Recommend repairs as needed. Sliding door on rear deck is missing a locking lever and catch assembly so door cannot be latched or locked. On man door going from house to garage "breezeway" there are no self-closing hinges.

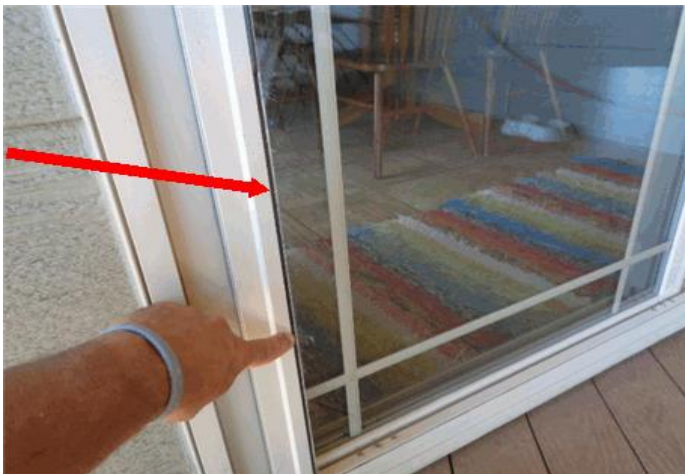
15) Screen Door

On sliding glass door at rear deck, the screen is totally missing.

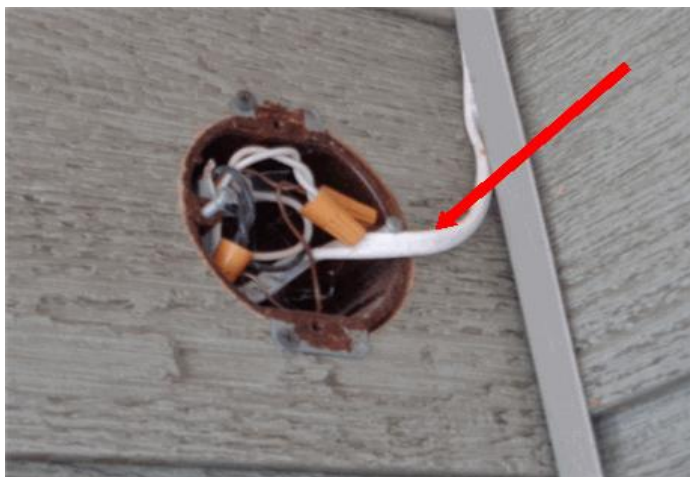
16) Exterior Electrical

At back sliding glass door, the light fixture is missing which results in an open junction box with a wire not properly placed in conduit.

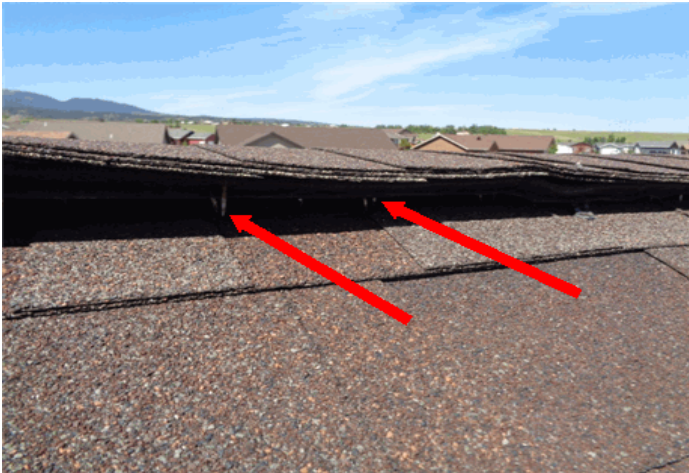
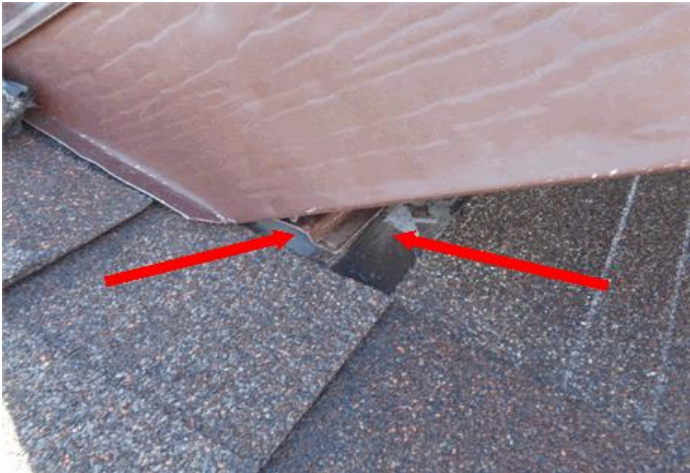
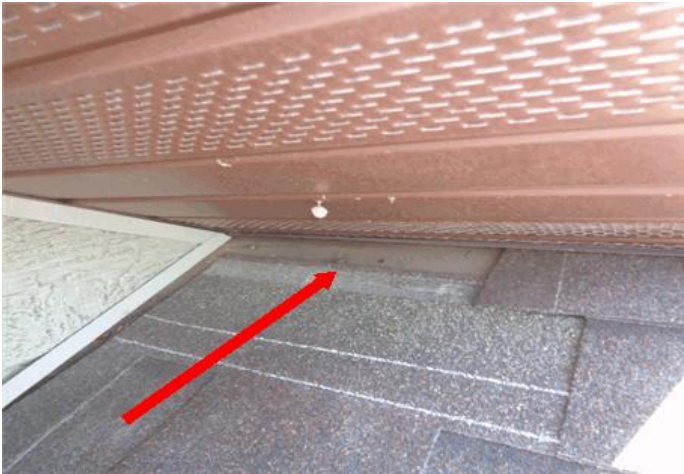
Method of Inspection	The roof was inspected by walking the safe and accessible areas.
Roof Style	Gable
Roof Covering Material	Asphalt composition shingles.
Number of Layers	One
18) Roof Covering Condition	<div>R</div> The ridge cap/vent on east rear side has nails that are too short, not able to penetrate through roof sheathing. On west side gable under gable overhang, there are gaps in the roofing material where rain/snow can run underneath the roof shingle causing moisture damage. On east side gable under gable overhang, there is a gap in the roofing material where rain/snow can run underneath roof shingle causing moisture damage.

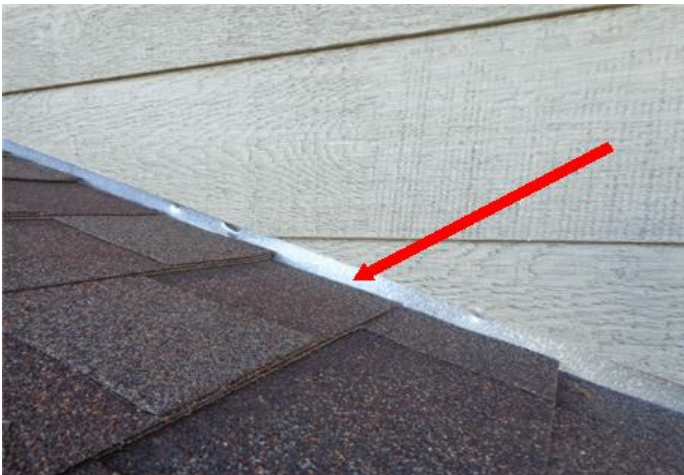
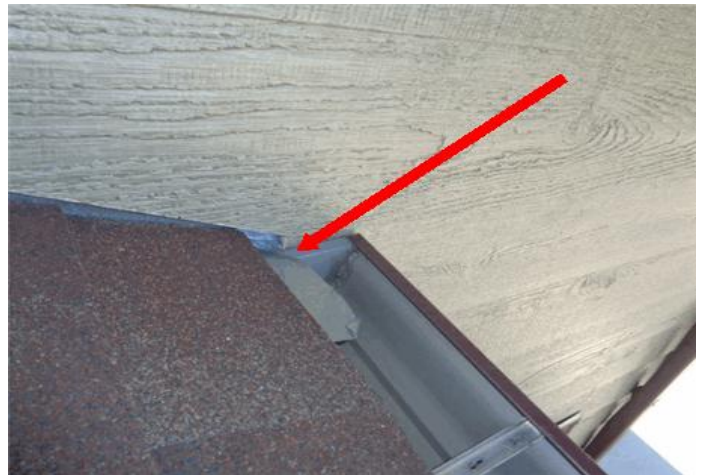
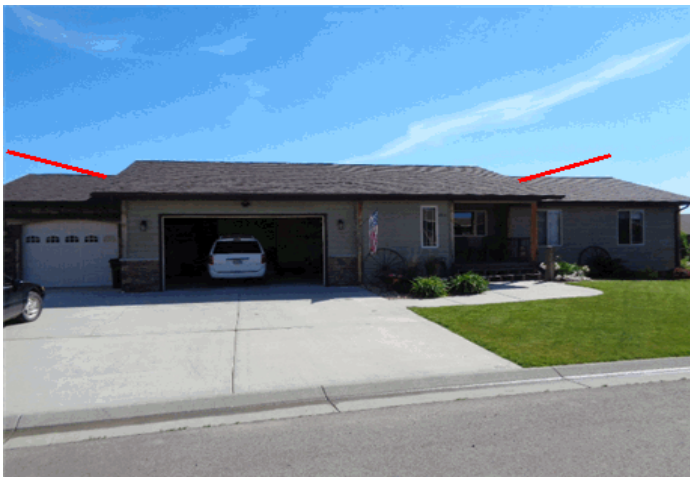
**19) Flashing Conditions****R**

There is no step flashing, just a common flashing on the gable ends. Step flashing is the proper flashing method. There is no kick out flashing on west side which will cause water to run behind the siding and rot the back of the siding and sheathing of home. It is suggested that a "Licensed Roofing Contractor" be contacted for further evaluation and repair.

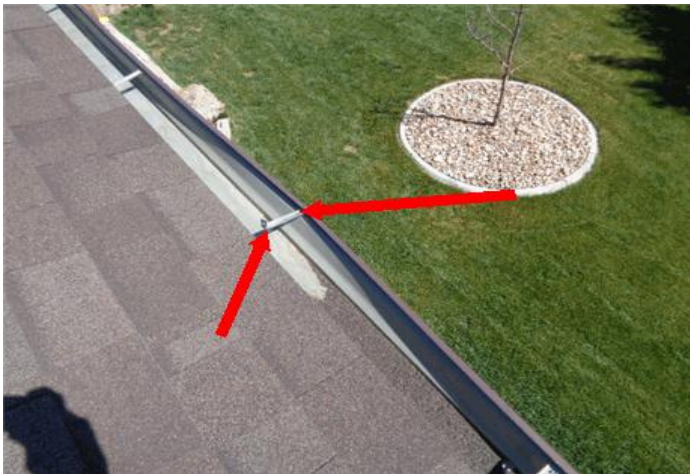
20) Gutter & Downspout Conditions

The gutter on the rear (north) side of home is bent and gutter hanger is damaged. Recommend repairs as needed.

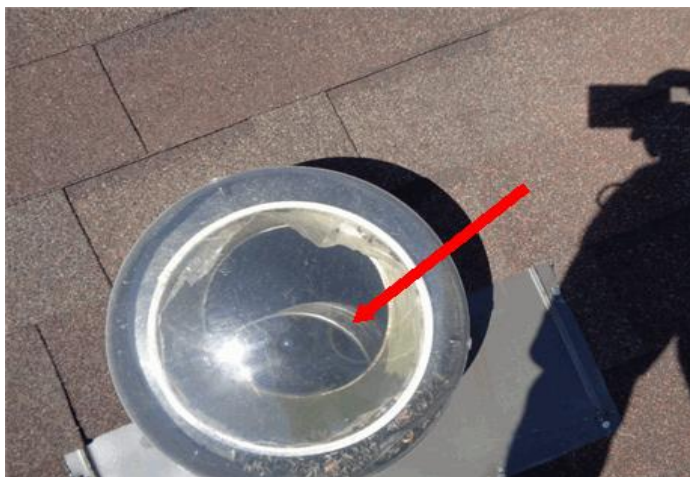
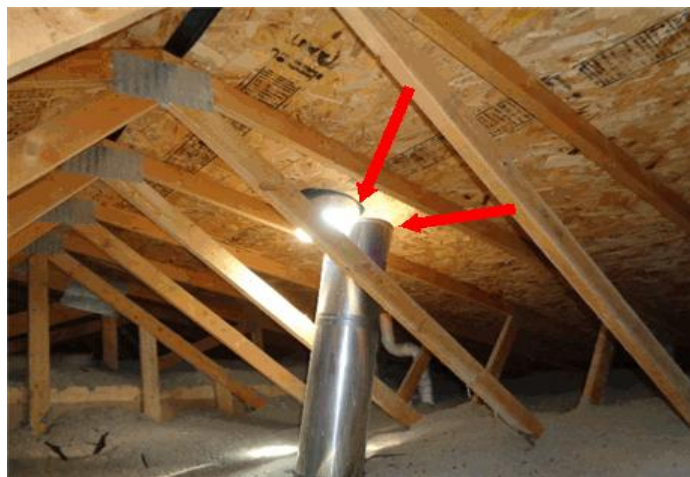
21) Attic Conditions

The solar tube for main bath is separated and coming apart in the attic. Recommend repairs as needed.

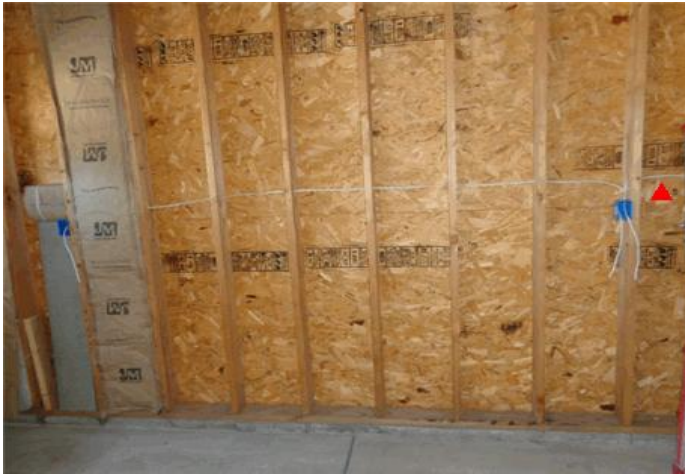
31) Electrical Conditions R The garage is being wired with 14 gage wire for receptacles which will allow for a 15 amp circuit which is not recommended for receptacle circuit. 12 gage wire and 20 amp circuits are recommended.

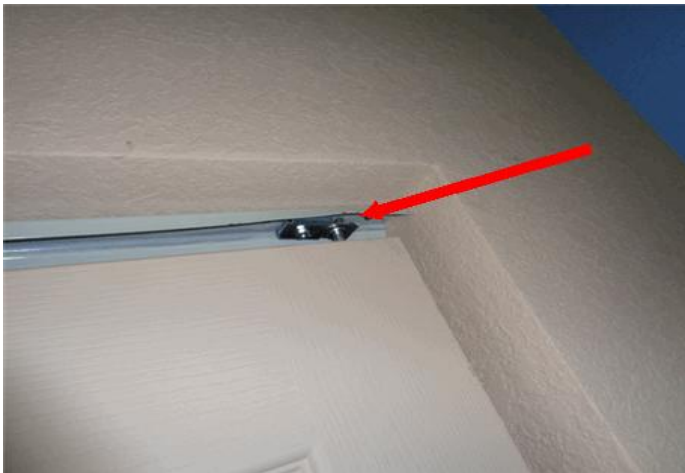
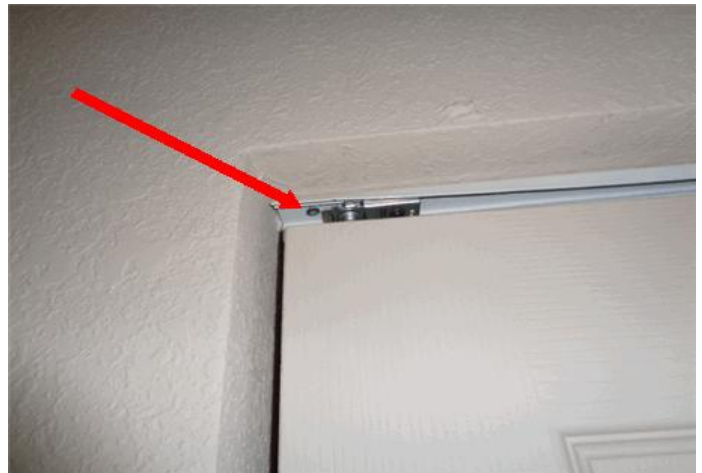
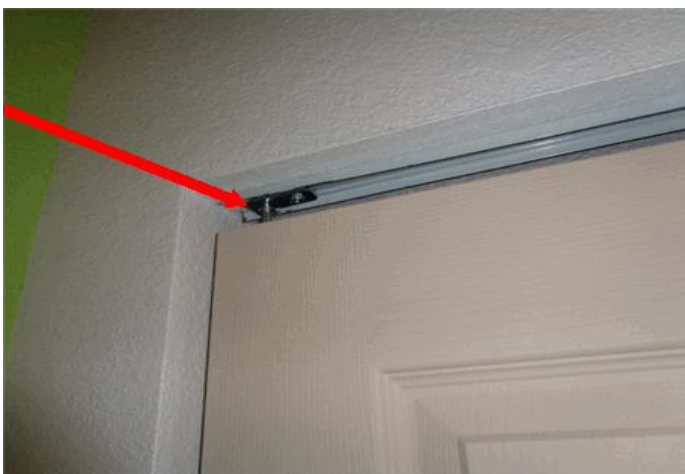
The bi-fold door track hardware in the two smaller bedrooms is damaged/bent. (Eventually they will pop out of track.) Recommend repairs as needed.

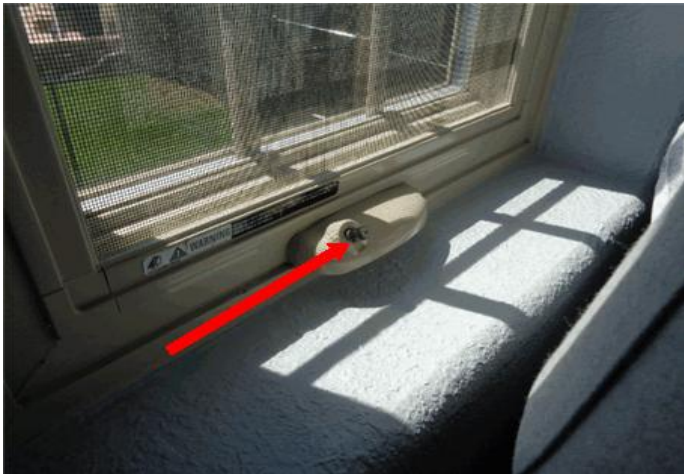
Window not operable. Crank missing from Master Bedroom casement window on east wall.

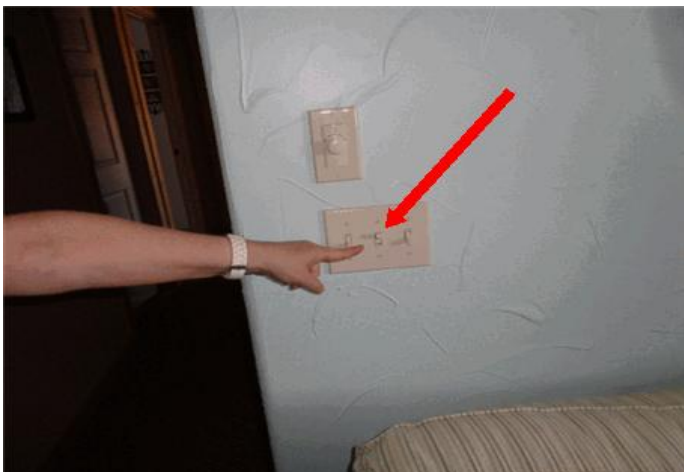
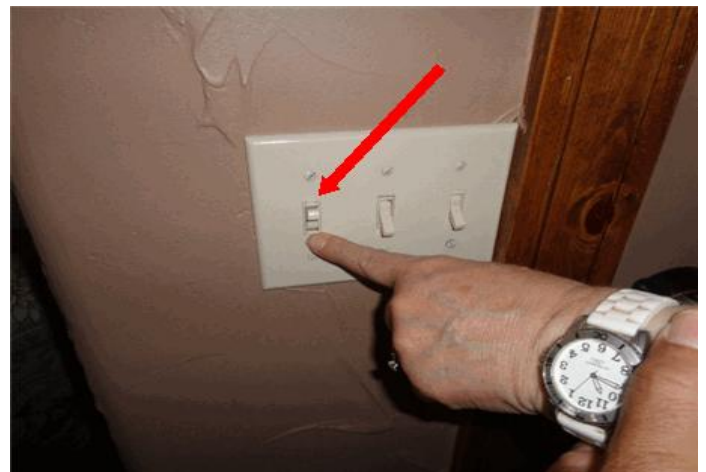
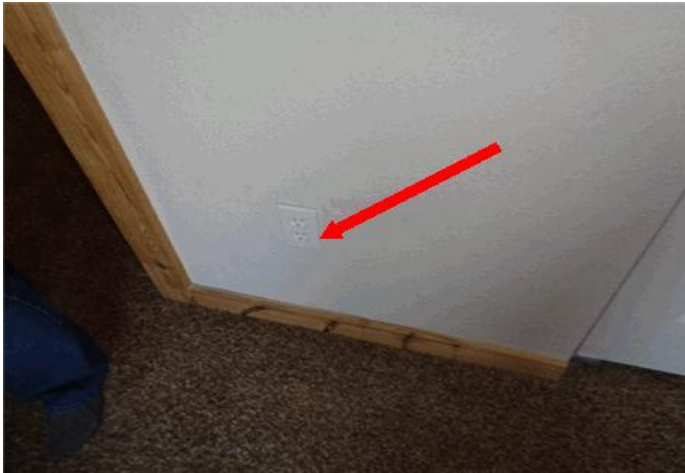
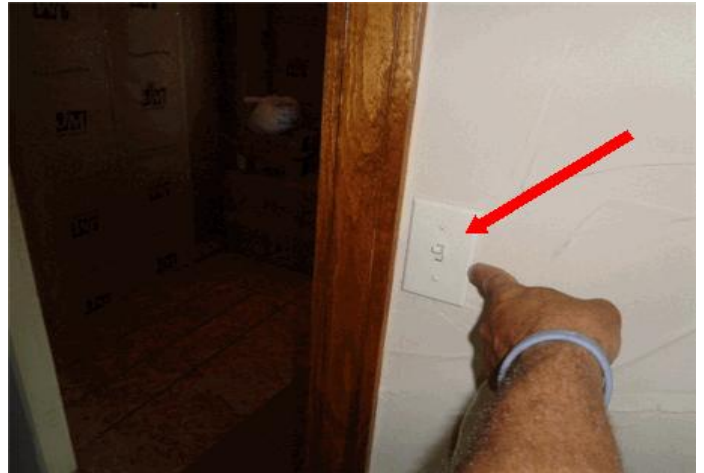
Electrical Conditions**43) Electrical Conditions****R**

The electrical switches in living room and front entry door are 3-way switches which inspector could not find what they operated. Client will have to discuss with current owner. Receptacle (below light switch) in southeast bedroom is loose. Light switch at man door going to "breezeway/garage" off of kitchen has a light switch that inspector could not determine what it operated.

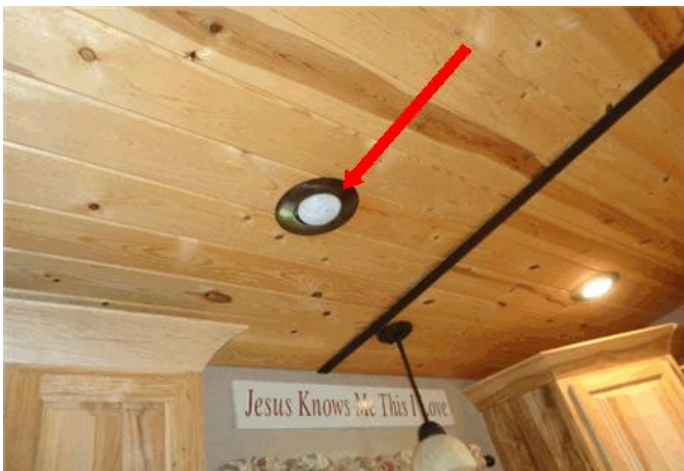
53) Lighting Conditions**R**

Can light above kitchen sink not operable. Recommend repairs as needed.

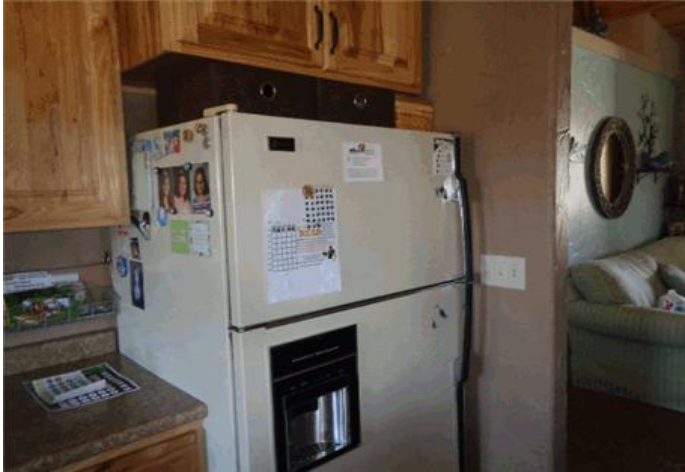
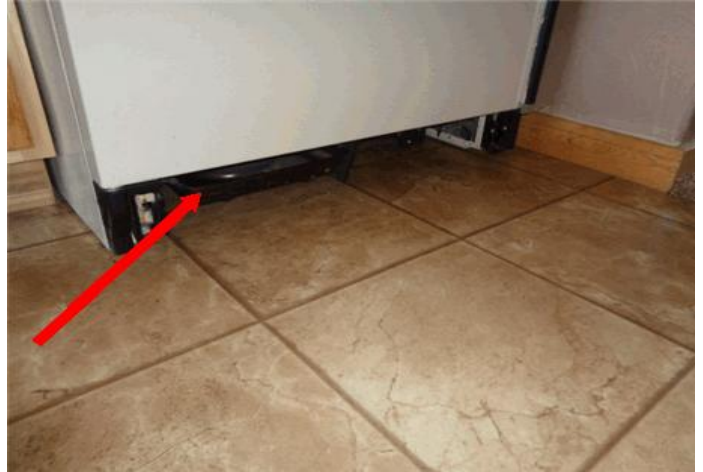
62) Refrigerator Conditions

Refrigerator is missing bottom cover.

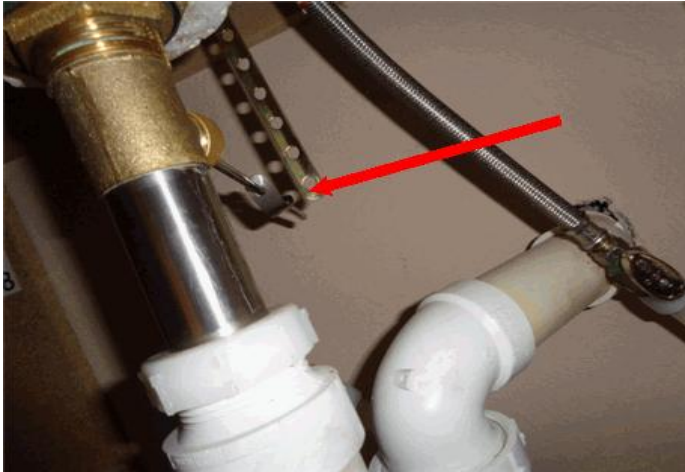
72) Sink Conditions**R**

Sink stopper not hooked up. The bathroom sink appeared to be in serviceable condition at the time of the inspection. The faucet appeared to be in serviceable condition at the time of the inspection. The visible areas of the plumbing under the bathroom sink appeared to be in serviceable condition at the time of the inspection.

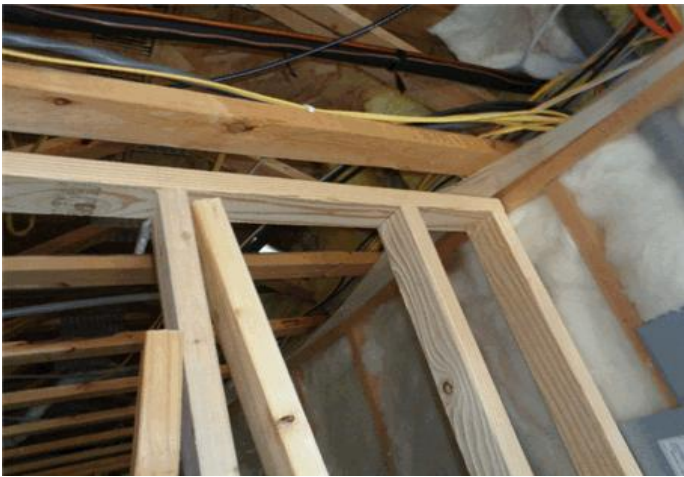
88) Wall Conditions**R**

Unfinished basement. Some frame walls are not secured at the top plate.

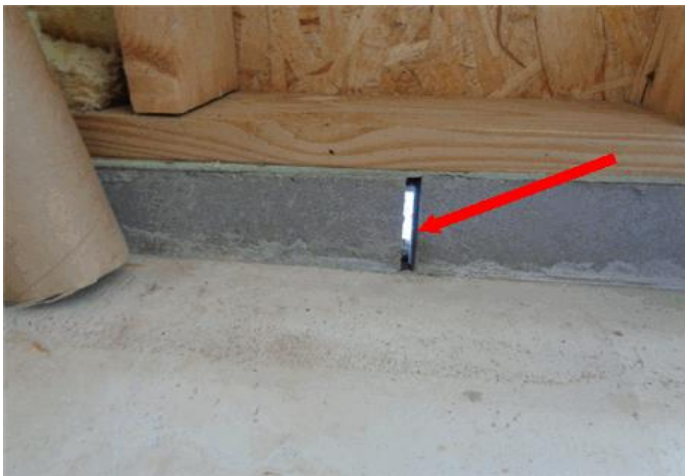
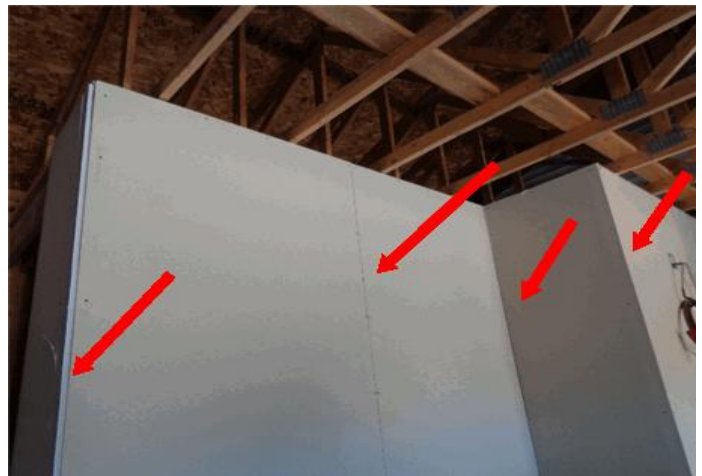
96) Wall Conditions

Front wall in garage has open mortar joint showing daylight to the outside. Needs to be sealed to prevent moisture, insect, rodent intrusion. Open studs. On walls where there is drywall, it needs to be fire-taped.

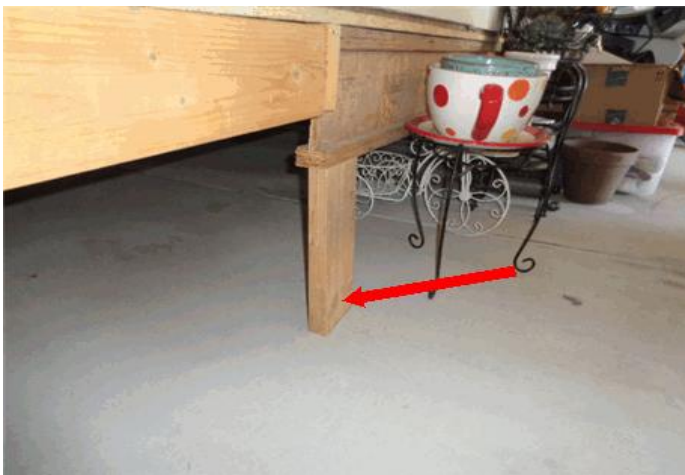
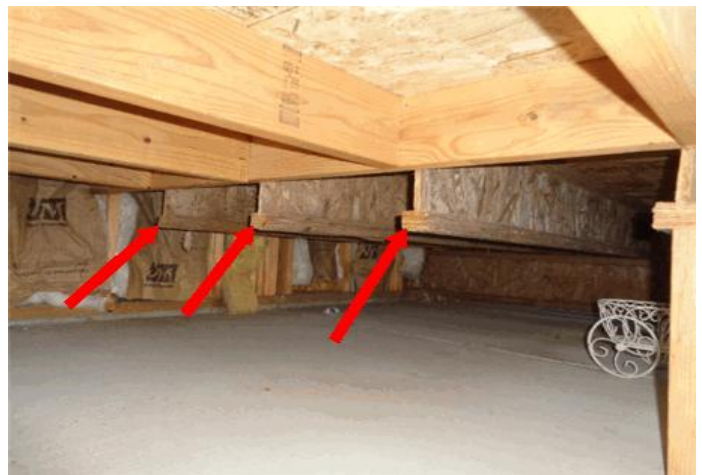
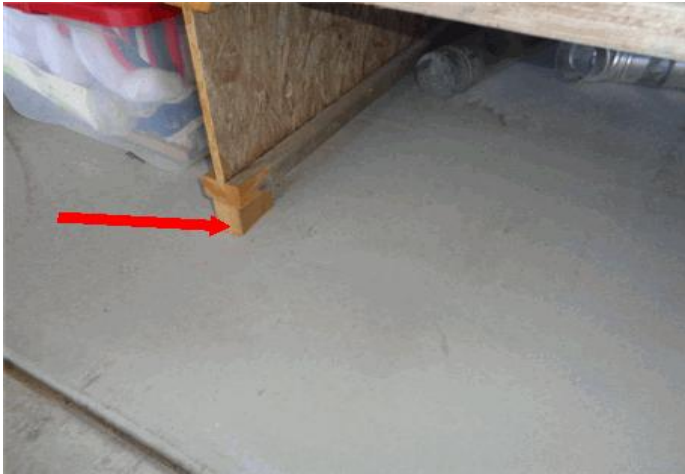
98) Floor Conditions

The raised "breezeway" floor trusses are not supported with top flange hangers. The support under the outside joist needs at least 3 inches of bearing under it (double 2x4).

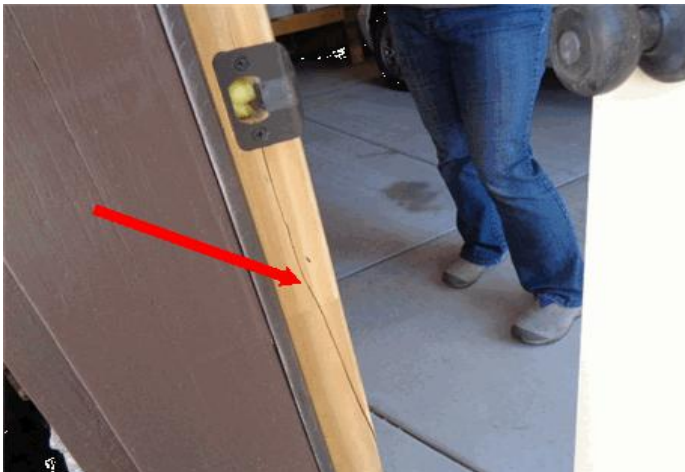
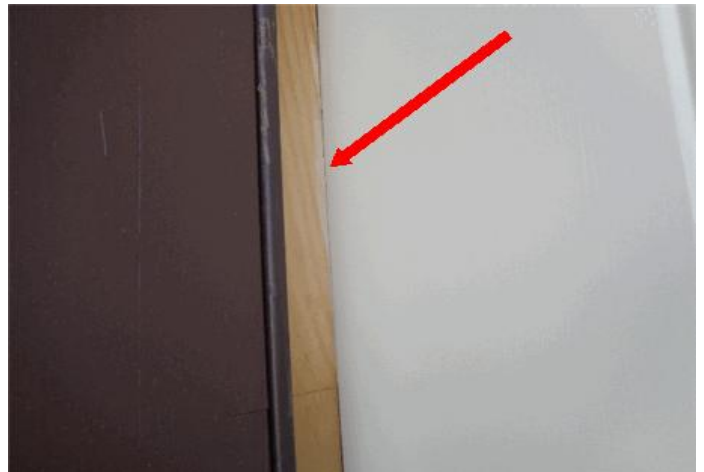
100) Door Conditions**R**

Garage side man door needs to be adjusted because it is hitting the jamb towards the top. The door jamb is also cracked under the strike plate. Recommend repairs as needed.

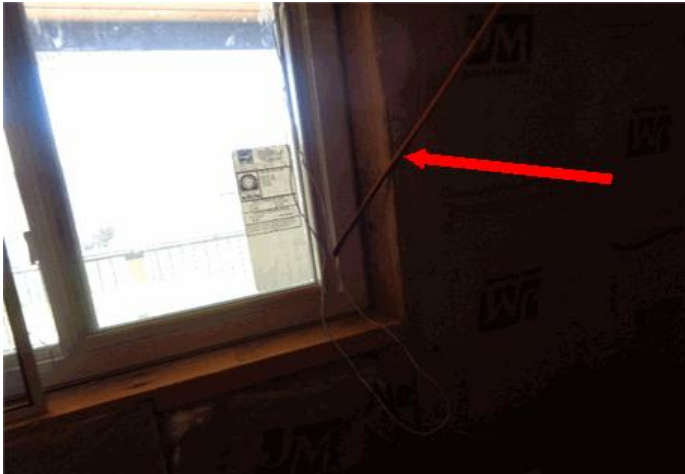
102) Electrical Conditions**S**

100	Repair	Garage side man door needs to be adjusted because it is hitting the jamb towards the top. The door jamb is also cracked under the strike plate. Recommend repairs as needed.
102	Safety	Extension cord plugged into back deck outlet runs through rear "breezeway" window to power garage door opener.
