Inspection Report

J & K Inspections, LLC

908 Black Hills Drive
Spearfish, SD 57783

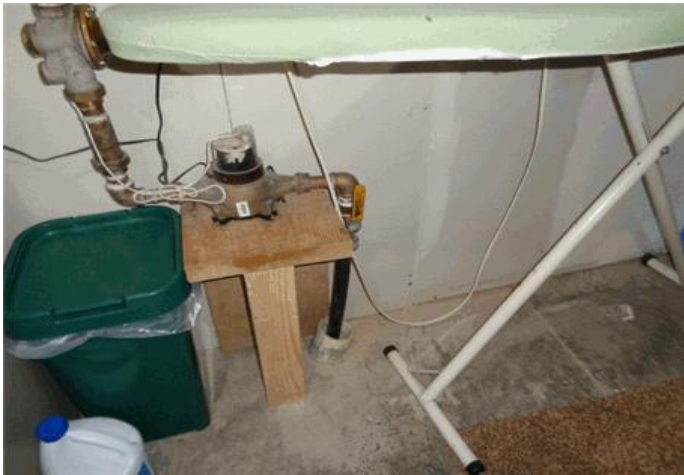
32) Main Line & Valve Conditions**AS**

The visible portion of the main pipe and valve appeared to be in serviceable condition at the time of the inspection.
